CONSTRUCTION OF SUBSTRUCTURE  
MAYFAIR PUMPING STATION, CHICAGO.

J. T. LUCAS

CONSTRUCTION OF SUBSTRUCTURE  
OF MAYFAIR PUMPING STATION  
CITY OF CHICAGO

A THESIS

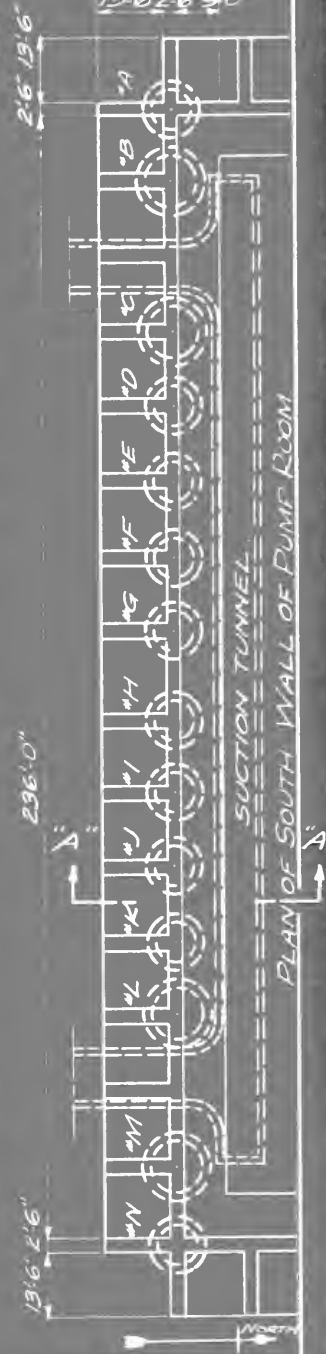
PLATE NO. 5  
25'-0"  
13'-6" 26'-9"

MAYFAIR PUMP STA  
South Wall Caissons

Section "A-A"  
Scale 1/8" = 1'-0"

SUCTION TUNNEL  
PLAN OF SOUTH WALL OF PUMP ROOM

Referring to Plate No. 5, showing general plan and section of south wall of pump room, it will be seen that the counterforts are centered upon caissons. These caissons, which are of the open well type, extend down past suction tunnel and rest upon hard pan. The method employed in excavating wells consists as follows. A tripod and windlass arrangement was placed over each opening at elev.- 13.00', the level of bottom of wall trench. The core was removed by hand digging in five foot sections, the sides of caisson being well secured by five foot sets of 3" maple lagging held in place by steel rings 2'- 6" apart. In a few instances wet ground and soil resembling quick-sand were encountered, making it necessary to use shorter sets of lagging and also to thoroughly pack the voids behind lagging with hay. The excavated material was raised in buckets to level of trench bottom by hand and emptied into

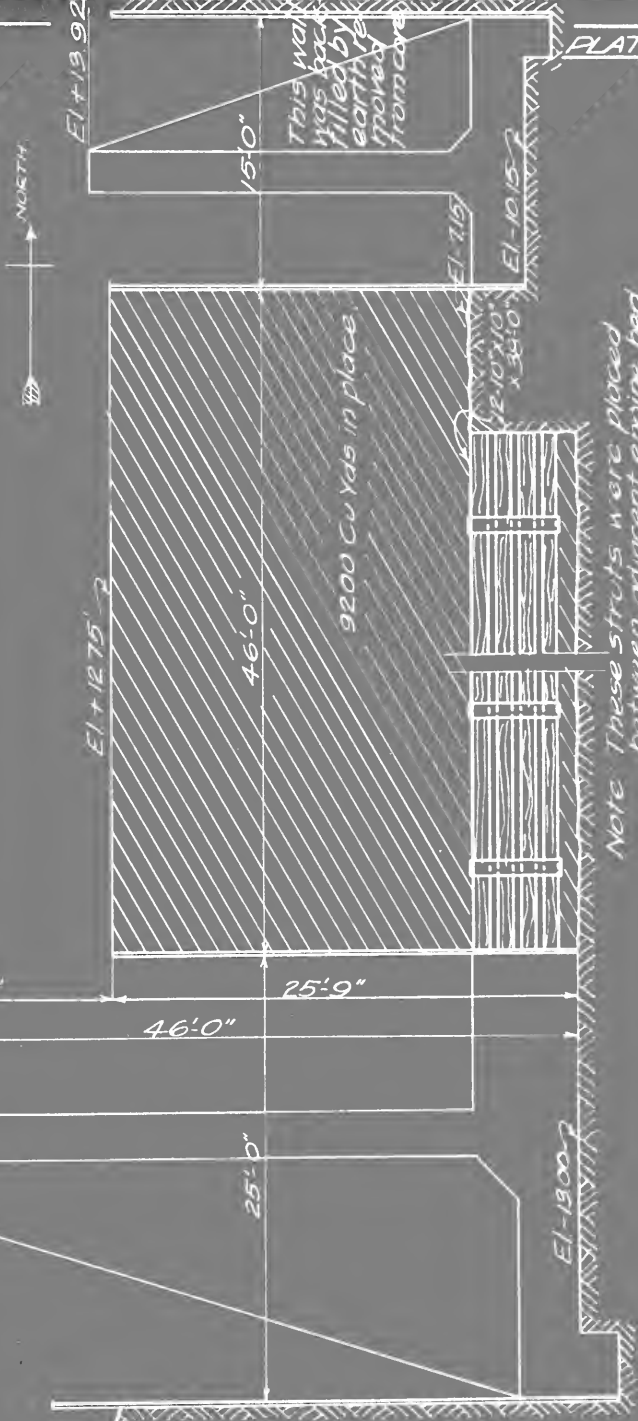
PLATE NO. 8

This wall was backfilled by earth removed from core

Note Core represented by shaded area 9200 cu yds was removed by steam shovel and loaded into dump cars. Loaded cars were elevated to surface by derrick and emptied behind walls as backfill.

Note These struts were placed between adjacent engine bed locations, 31'-0" c/c

TRANSVERSE SECTION OF PUMP ROOM  
MAYFAIR PUMPING STATION

between proposed adjacent engine beds. The purpose of these struts was to counteract any sliding motion on the part of either south or north walls. They were left in place until engine beds had been concreted as well as pump room floor section between north ends of pump foundations and north wall footing. Plate No. 8. shows analysis of procedure in core excavation. This practically completed all excavation for foundations of station.

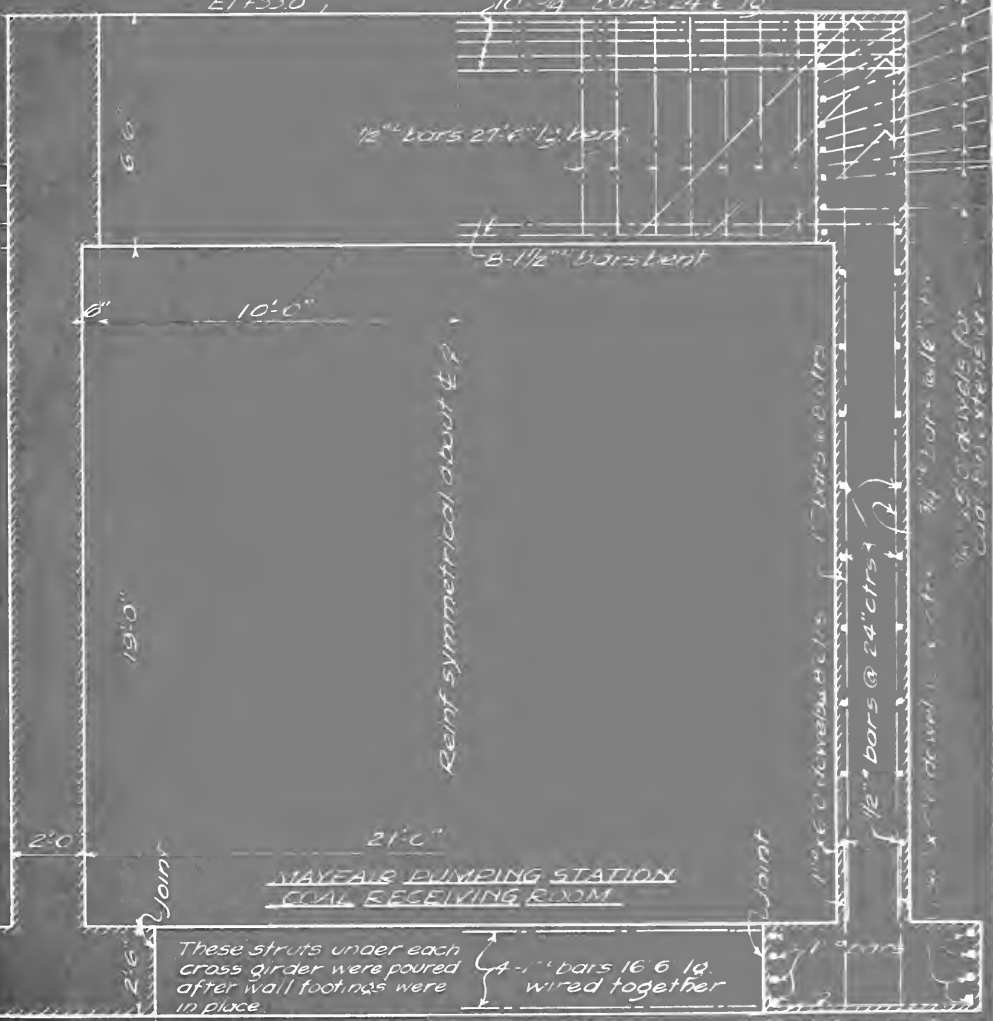
MAYFAIR PUMPING STATION  
COAL RECEIVING ROOM

These struts under each cross girder were poured after wall footings were in place

sand and gravel were heated by means of steam lines before being placed in mixer. Plates No. 9. & 10. show sections of formwork and details of walls and girders in coal receiving room.

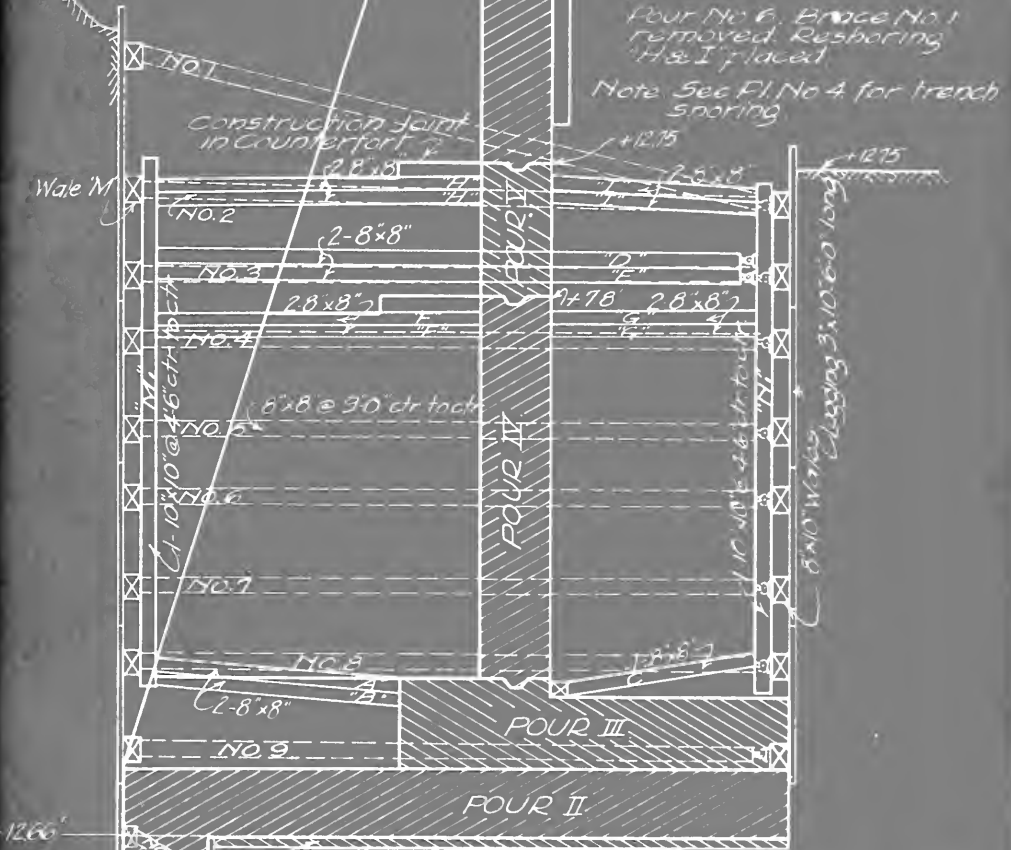
Original trench shoring represented by dotted lines - Nos 1 to 9 inclusive.

MAYEAK PUMPING STATION  
METHOD OF CONCRETING  
PUMP ROOM WALLS

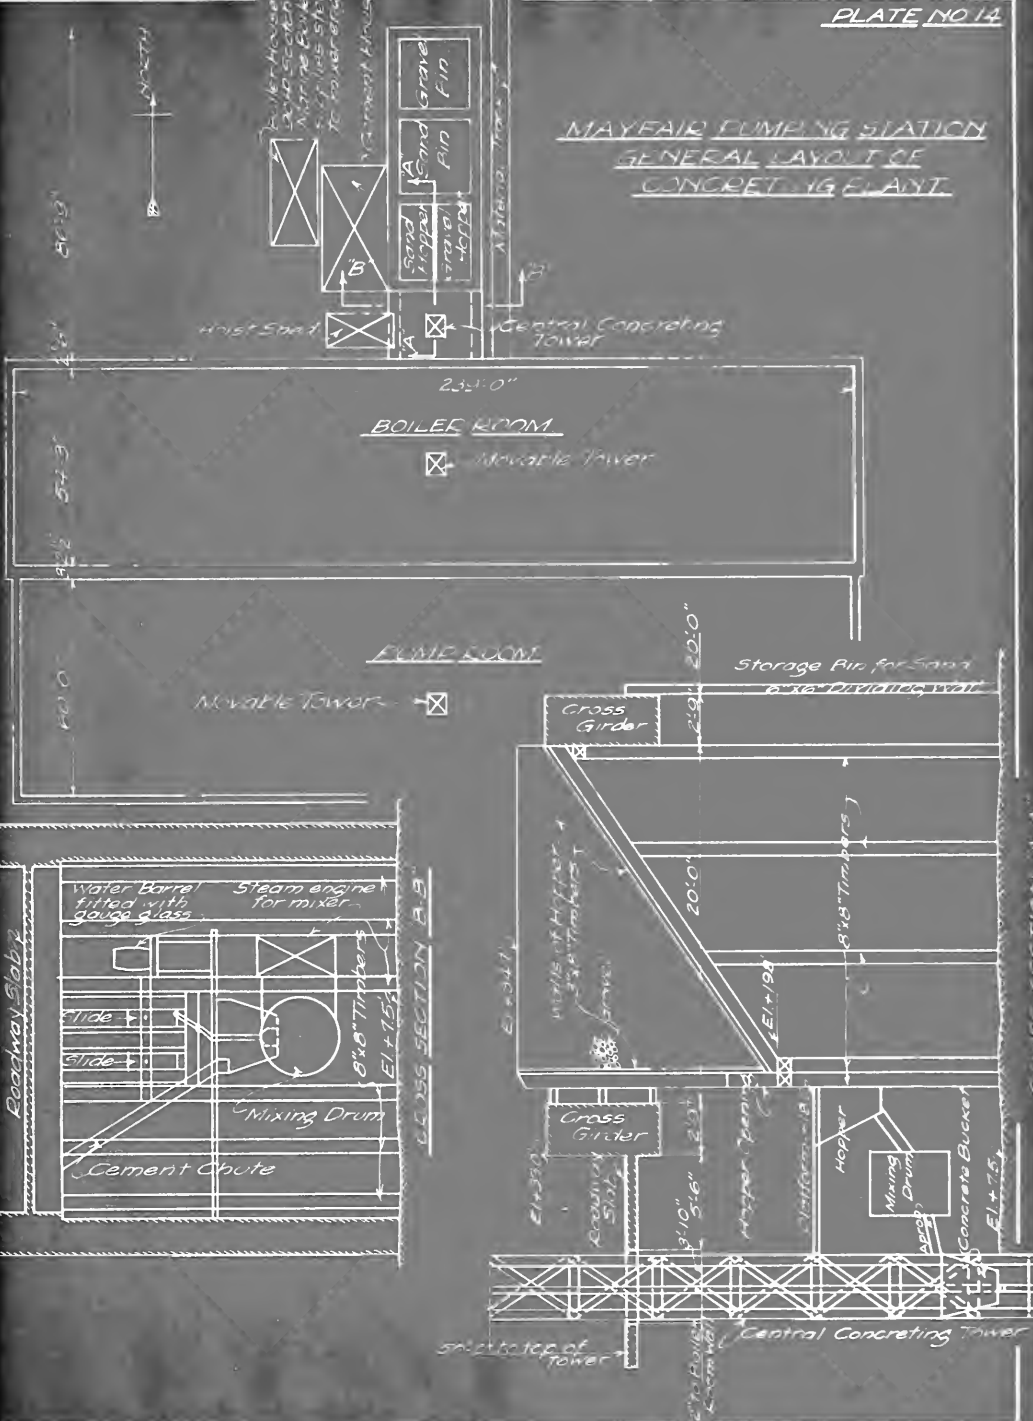
MAYFAIR PUMPING STATION  
GENERAL LAYOUT OF  
CONCRETING PLANT.

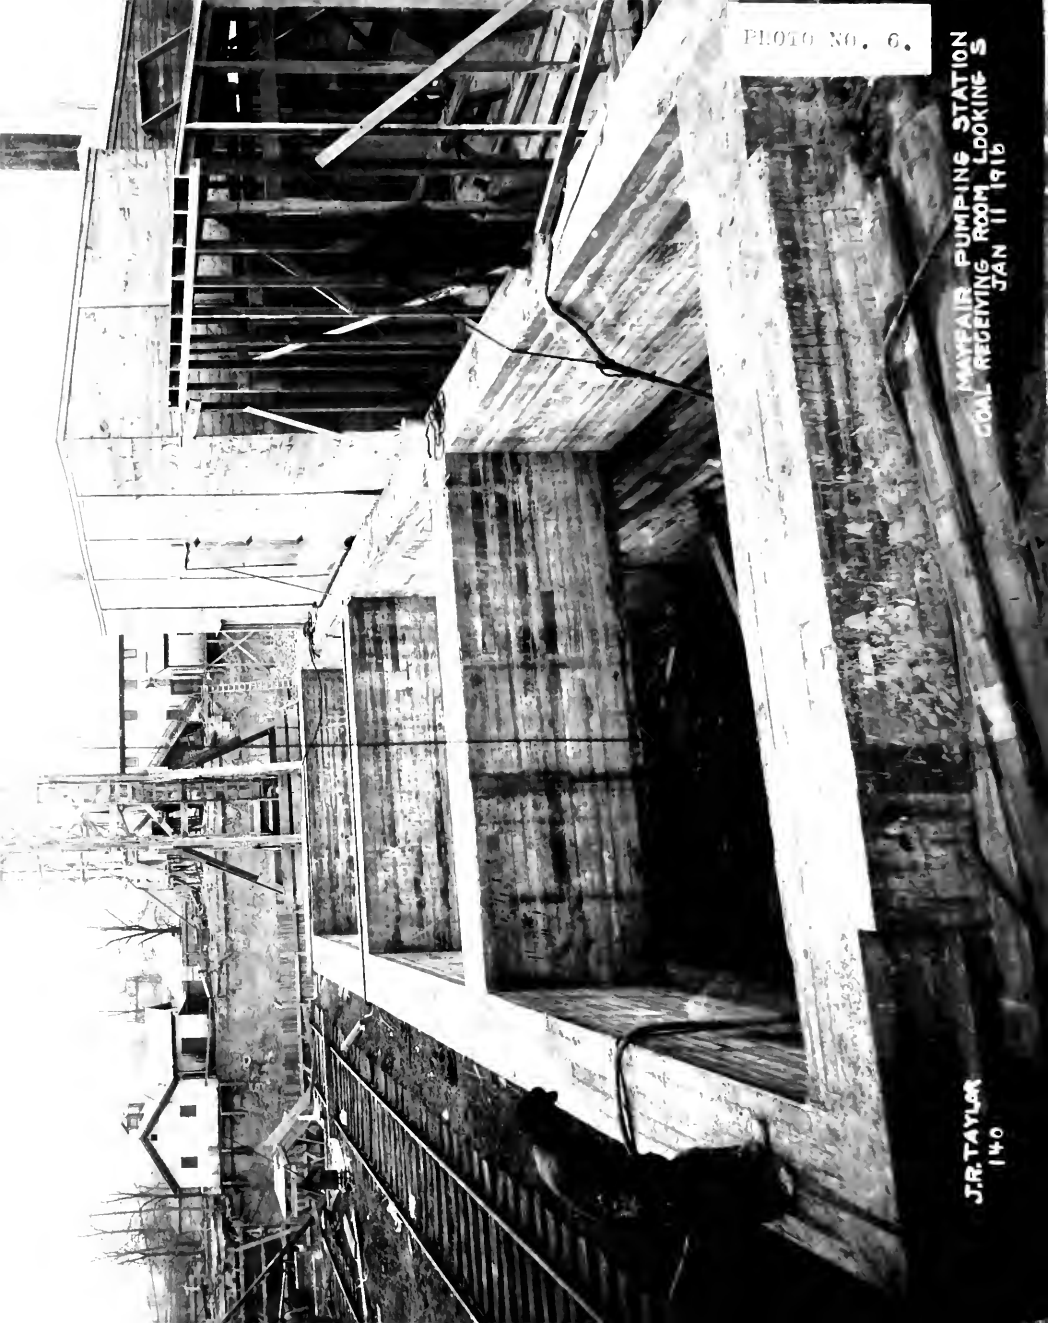
MAYFAIR PUMPING STATION  
COAL RECEIVING ROOM LOOKING S  
JAN 11 1915

- Photo No. 1. General View of Work in Preliminary Stages.
- Photo No. 2. North Boiler Room Wall.
- Photo No. 3. Open Cut Excavation by Steam Shovel.
- Photo No. 4. Trench Bracing for Pump Room Walls.
- Photo No. 5. General View of South and West Engine Room Walls.
- Photo No. 6. Coal Receiving Room.
- Photo No. 7. Boiler Room.
- Photo No. 8. Pump Room.
